# PIT tag Interrogation Site: Prosser (PRO) Chandler Dam, Prosser WA.

Recent effects on PIT tag interrogation system caused by the introduction of Full Duplex (FDX) tagged Lamprey.

### 22 May 2017

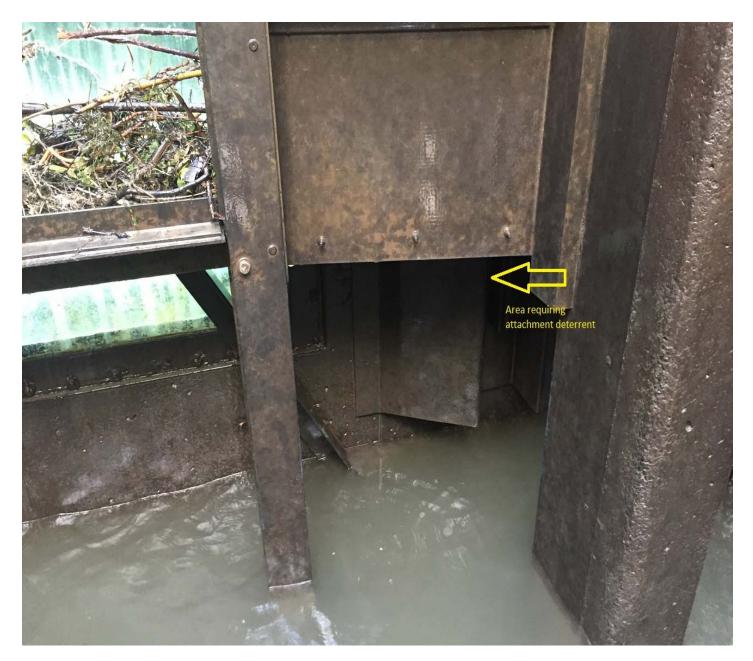
# - FIBERGRATE 16015 GRATING, TYP Antenna Slight possibility for Lamprey to be read if attached in this location (Refer to picture 4) Top View PRO Right Ladder -Most likely area for Lamprey to be read if-attached in this location. Deterrent to be placed on guide near bottom of antenna FISH VIEWER WINDOW BACKBOARD COLUMN GUIDE, TYP FLOW Slight possibility for Lamprey— to be read if attached in this location (Refer to picture 3) Antenna - FIBERGRATE 16015 GRATING

Picture 1. Upstream area of counting window, arrow shows antenna guide.

- Tag lamprey with HDX tags instead of FDX. Turn on "Reader Dual Mode FDX/HDX" detection.
  - o With this solution, there is still a slight possibility of missing FDX tags.
- Install lamprey attachment deterrents in specified areas, reference Drawing 1. See Pictures 1,2,3,4,
- Enhance the passage over the dam with a half-duplex Lamprey Passage System (LPS) that routes
  the lamprey away from the counting window passage route. Examples would be Bonneville WA.
  Shore LPS and 3 Mile Dam LPS on the Umatilla River.

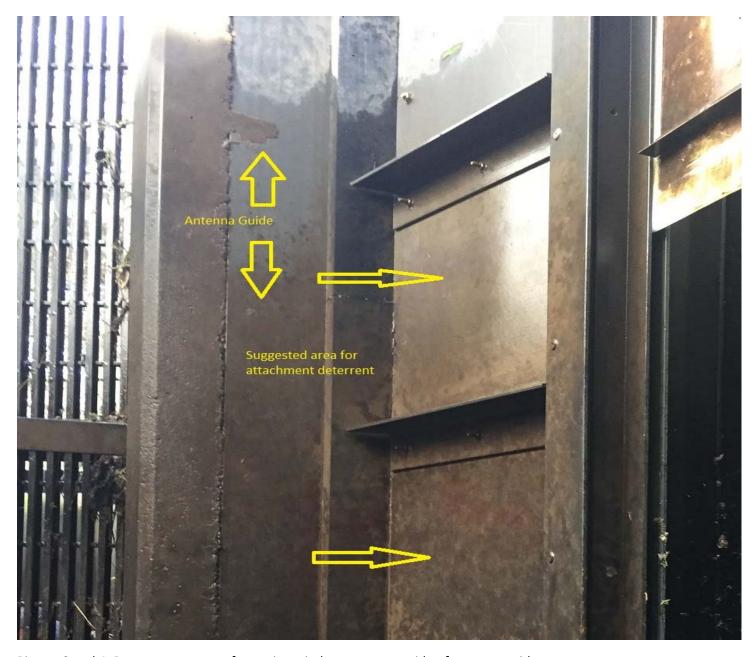
Picture 2 and 4. Downstream area of counting window, upstream side of antenna guide.

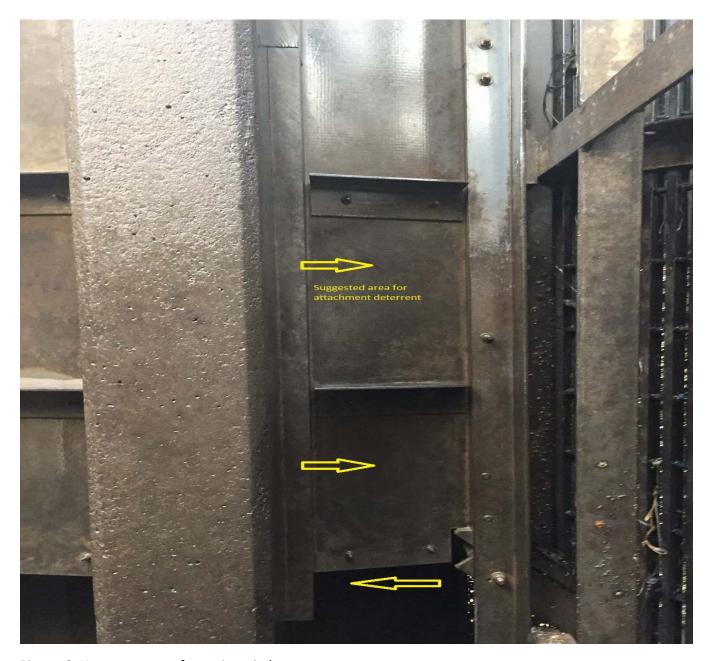
Picture 3. Upstream area of counting window.

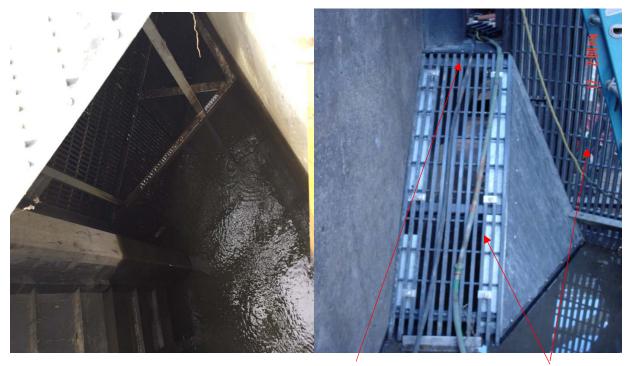
Picture 5. Area where lamprey are holding up.

Picture 6. Areas where lamprey are squeezing through the grating.
