PTAGIS O&M Concerns Using FDX Tags In Adult and Juvenile Lamprey Studies

Version 1.0
April 18, 2018

Prepared by:
Scott Livingston, John Tenney, Don Warf, Jennifer Lundy

Pacific States Marine Fisheries Commission
205 SE Spokane St., Ste. 100
Portland, OR 97202

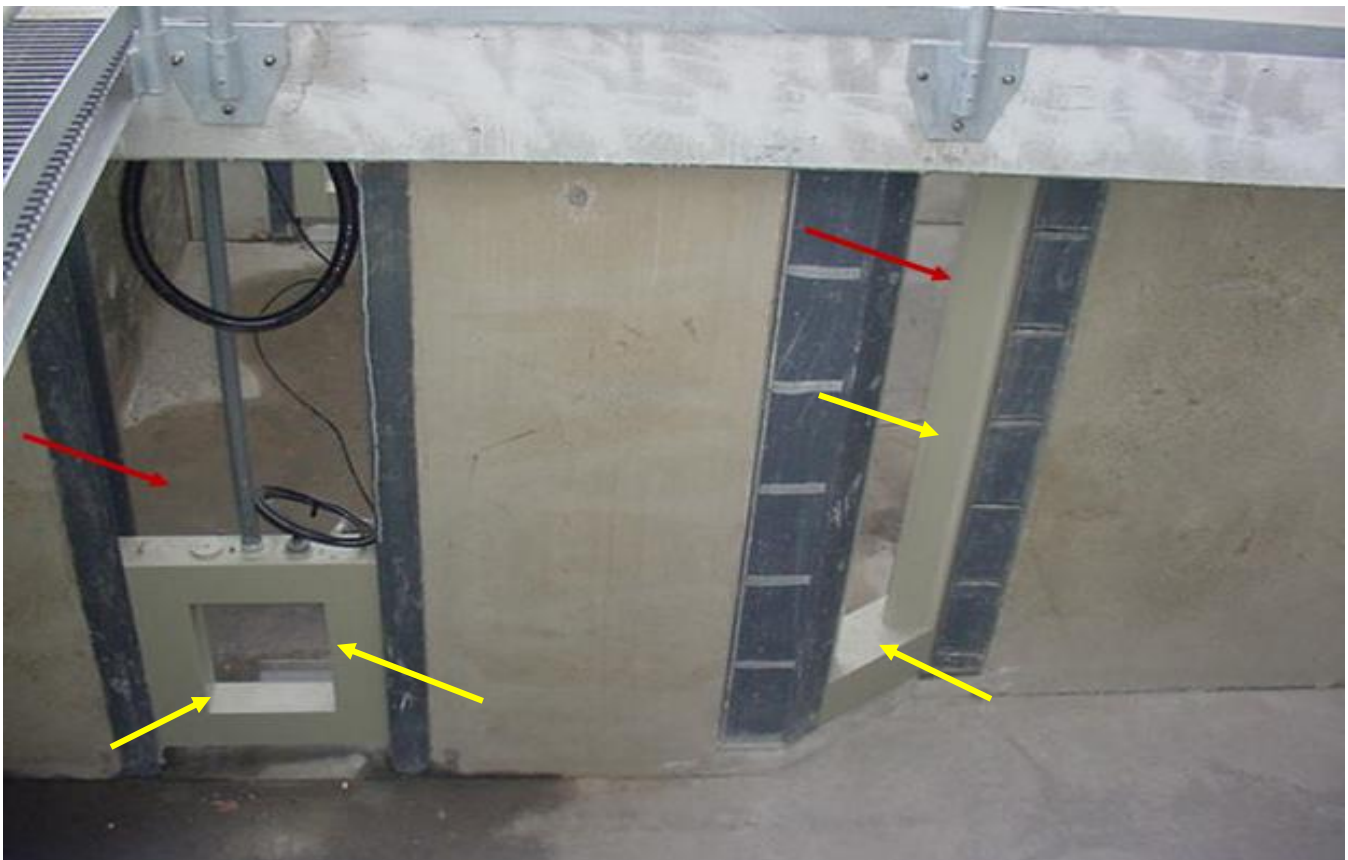
Picture 1. Upper Ladder Orifice and Slot antennas

- 8 antennas located in the upper section of the ladder, 4 Slot and 4 orifice style.
- 8 antennas located in the lower section of the ladder, 4 slot and 4 overflow style.

- 2 antennas located at the exit of the ladder, pass-thru style.

- Red arrows show placement of FDX antennas.
- Yellow arrows are examples of potential lamprey attachment locations.
- As picture indicates, antennas are smooth on all sides ideal for lamprey attachment anywhere within the activation field.

- All antennas within the Granite ladder are fitted with guides in the each weir wall that hold the antennas in place.

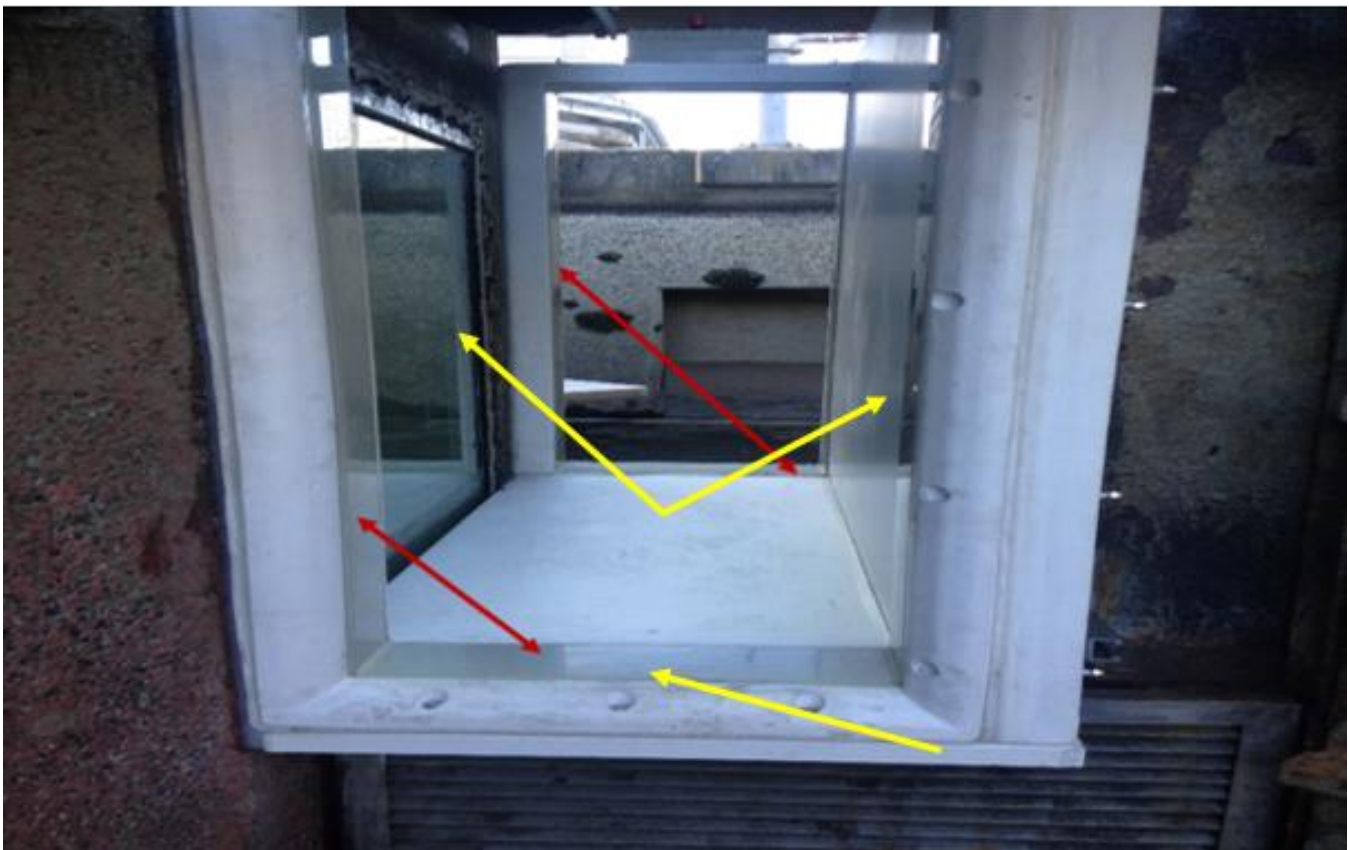
Picture 2. GOA Counting Window antennas

- Two antennas, pass-thru style, located within the confines of the counting window passage.

- Red arrows show placement of FDX antennas.
- Yellow arrows are examples of potential lamprey attachment locations.
- Antennas are smooth on all sides ideal for lamprey attachment anywhere within the activation field.

- Co-Polymer housing throughout entire Counting Window (CW) passage designed specifically for the FDX antennas. Entire CW assembly mounted to existing concrete and metal frame work.

- Slow moving water with smooth surfaces within the detection field.
- Ideal for lamprey attachment anywhere within the CW passage.

- The two antennas are the **ONLY** opportunity to detect adult salmonids passing Little Goose Dam.
- Areas behind the picketed leads where lamprey could attach and rest within the detection field.
- FDX tagged lamprey found to be jamming the detection field would likely require the entire ladder to be de-watered in order to locate and remove the lamprey from detection field.
- Overall detection efficiencies of adult salmonids would potentially be lost or significantly reduced due to FDX tagged lamprey in the area.
- Directionality information of adult salmonids potentially lost or significantly reduced.
- Regional studies that rely on accurate and high detection rates at this site could be negatively impacted.

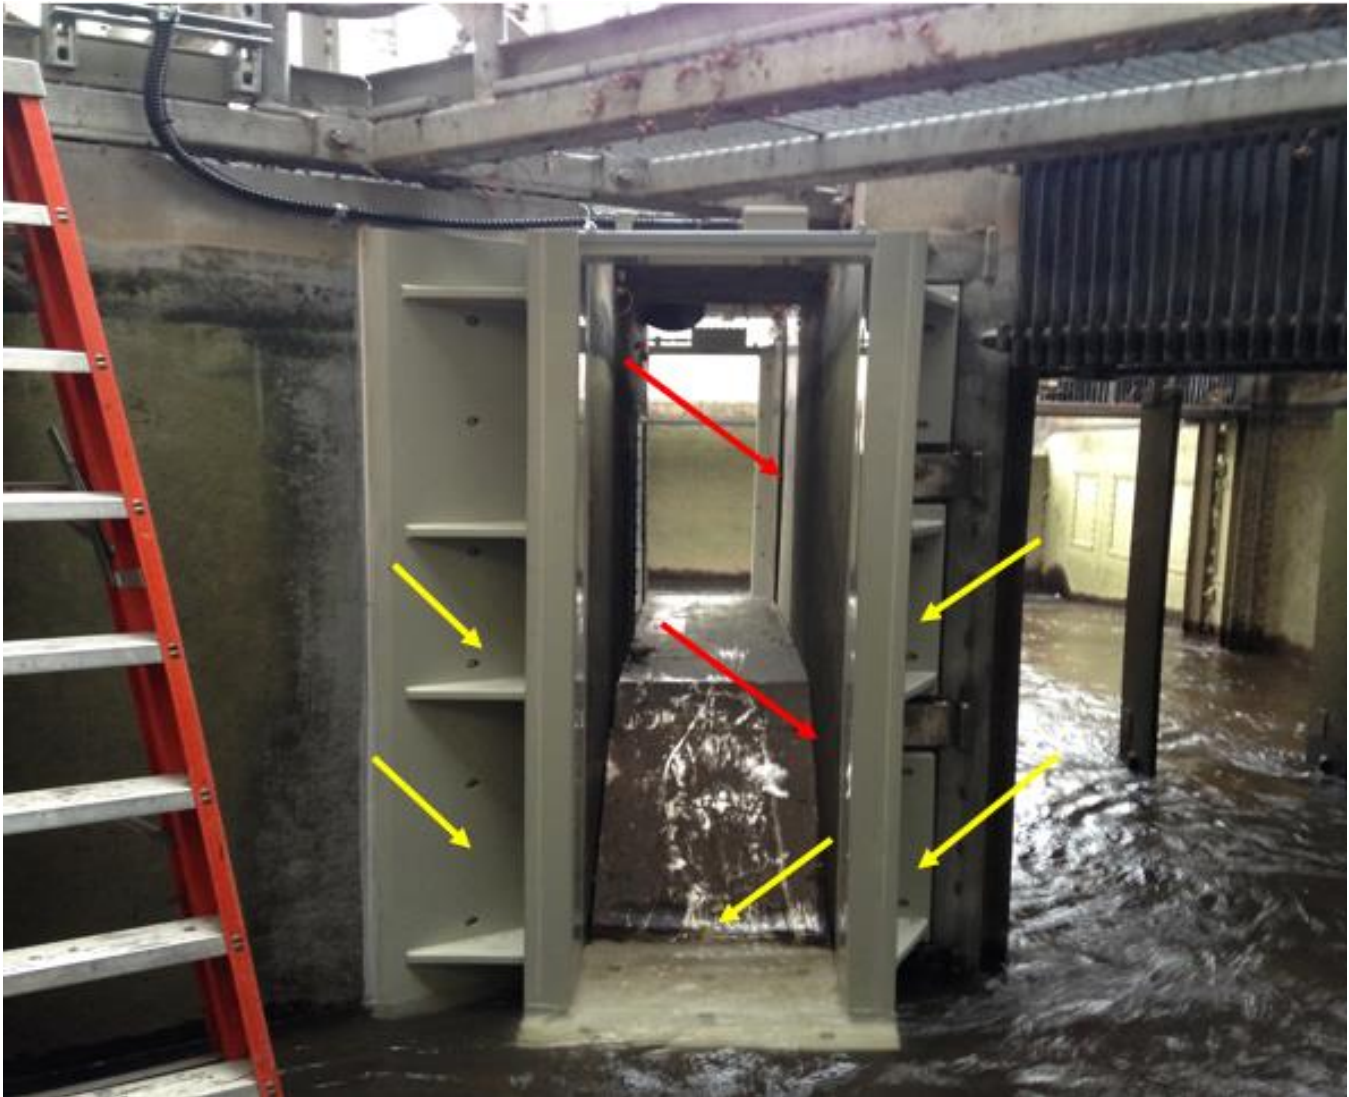
Picture 3. LMA north Counting Window antenna

- 2 antennas, pass-thru style, located within the confines of the counting window passage.

- Red arrows show placement of FDX antennas.
- Yellow arrows are examples of potential lamprey attachment locations.
- Antennas are smooth on all sides ideal for Lamprey attachment anywhere within the activation field.

- Metal frame mounted system, Co-Polymer antennas are custom built and designed around the existing metal frame and picketed leads.

- Slow moving water.
- Smooth surfaces within antenna detection field, ideal for lamprey attachment.
- Areas behind the picketed leads where lamprey could attach and rest within the detection field.

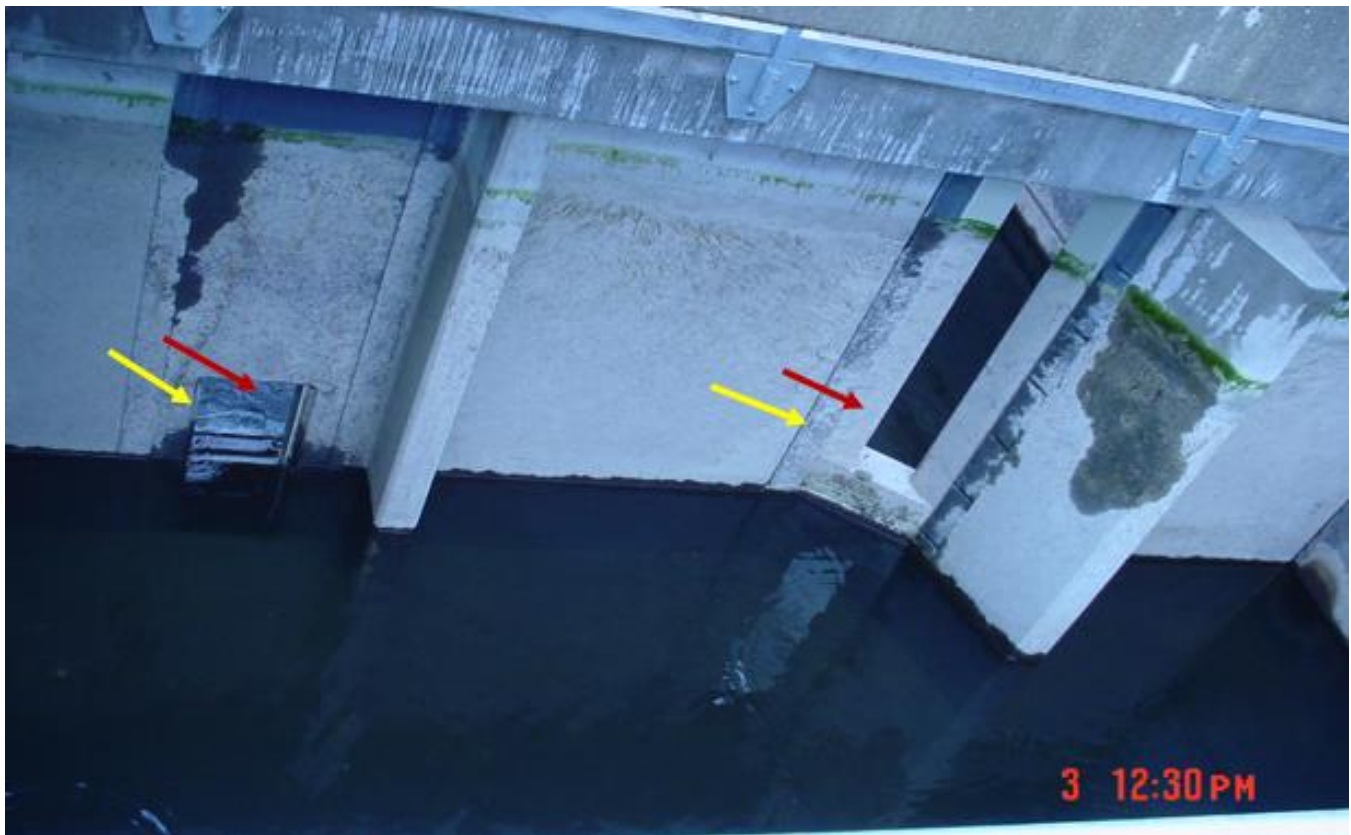
Picture 4. Typical Orifice and Slot antenna

- 8 antennas located in the upper section of the North ladder, 4 Slot and 4 orifice style.
- 8 antennas located in the upper section of the South ladder, 4 slot and 4 overflow style.

- All antennas within the Ice Harbor ladder are either embedded in, or bolted onto the concrete of the ladder.
- In some instances, the ladder has been retro-fitted to receive a specific antenna geometry.

- Red arrows show placement of FDX antennas.
- Yellow arrows are examples of potential lamprey attachment locations.
- As picture indicates, antennas are smooth on all sides ideal for lamprey attachment anywhere within the activation field.

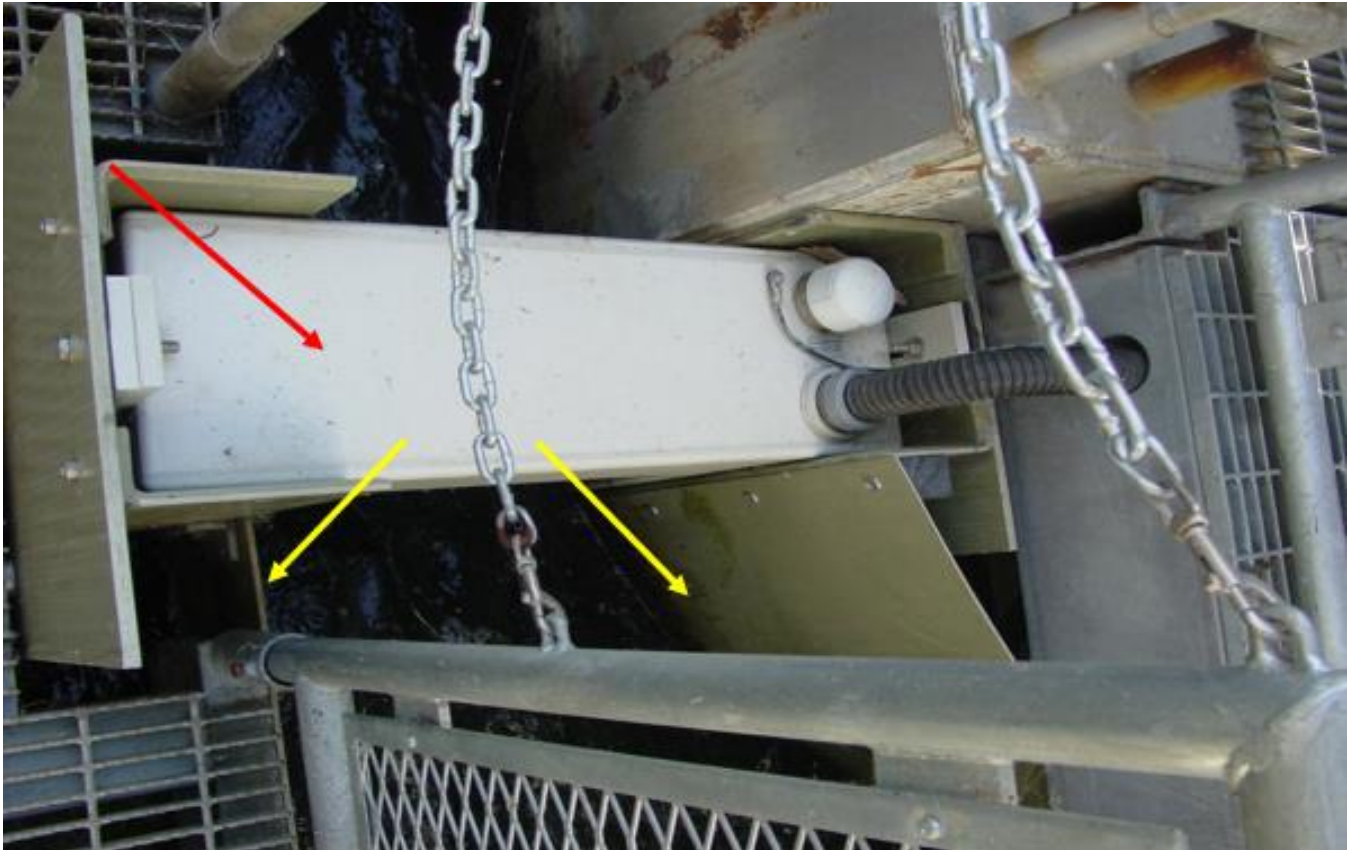
Picture 5. MC1 PIT tag detection array configuration.

- Two antennas, pass-thru style, located within the confines of the counting window passage.

- Metal frame mounted system, antennas are custom built and designed around the existing metal frame and picketed leads.

- Red arrows show placement of FDX antenna.
- Yellow arrows are examples of potential lamprey attachment locations.
- As picture indicates, antennas are smooth on all sides ideal for lamprey attachment.

- Slow moving water.
- Smooth surfaces within antenna detection field, ideal for lamprey attachment.
- Areas behind the picketed leads where lamprey could and become entrained.

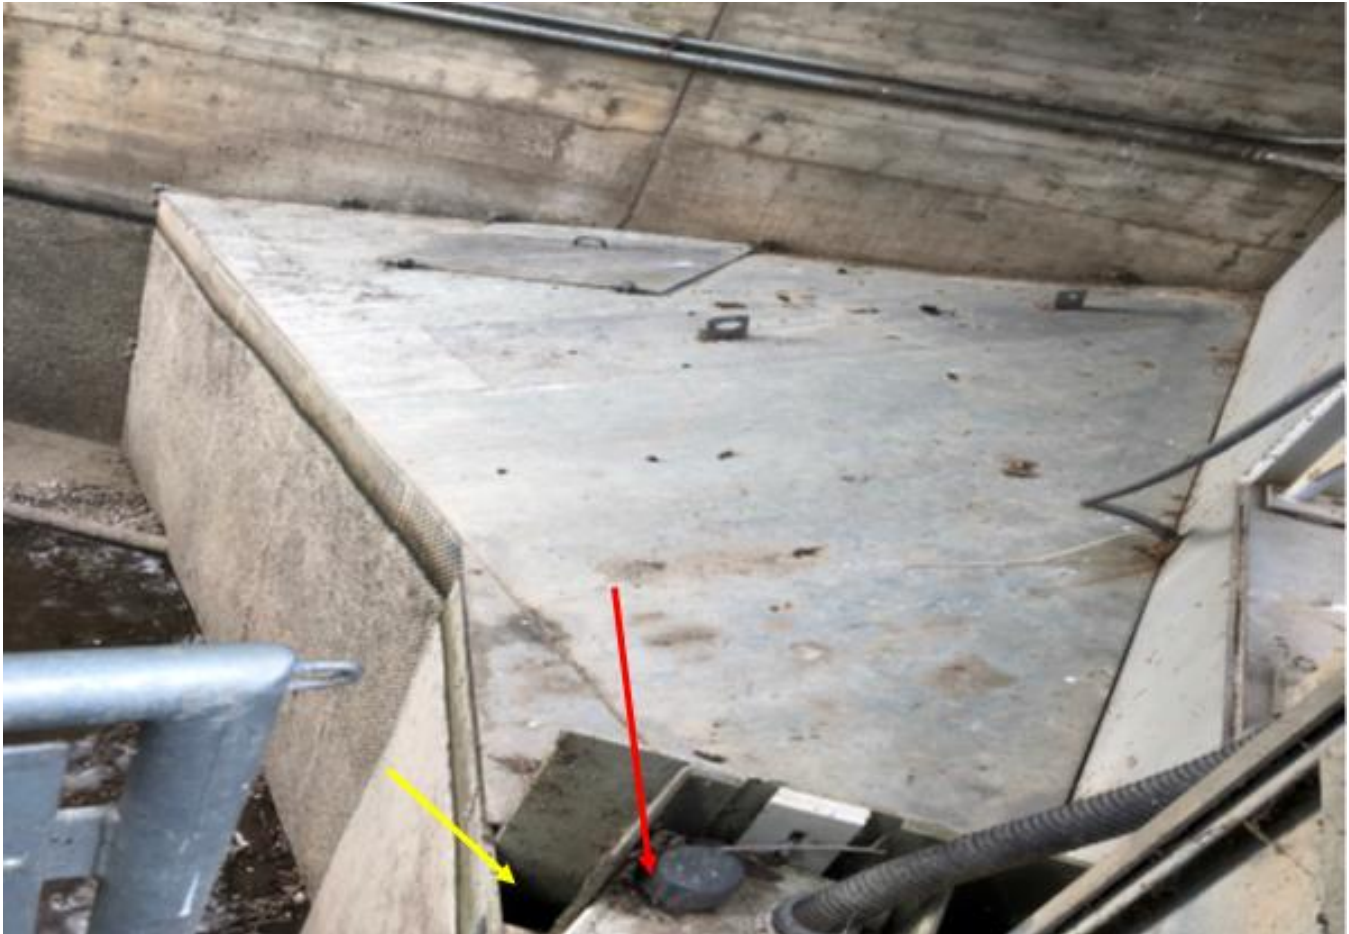
Picture 5a. MC1 Spacer section where lamprey have become entrained.

- Red arrows show placement of FDX antenna.
- Yellow arrow show location in spacer where FDX PIT tags could potentially be trapped and degrade detection efficiencies.

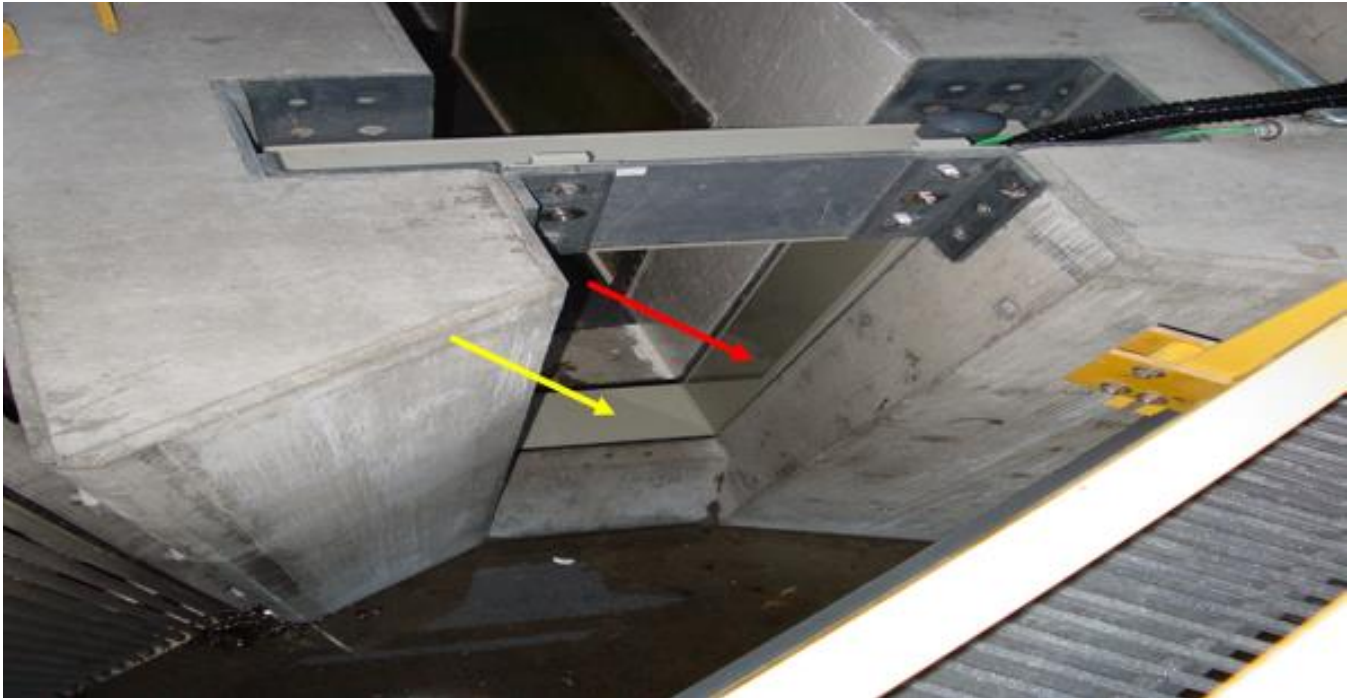
Picture 6. MC2 PIT tag detection array.

- Three antennas, pass-thru style, located within the confines of the counting window passage.

- Custom formed concrete throughout the entire counting window area.

- Red arrows show placement of FDX antenna.
- Yellow arrows are examples of potential lamprey attachment locations.
- As picture indicates, antennas are smooth on all sides ideal for lamprey attachment.

- Slow moving water.
- Smooth surfaces within antenna detection field, ideal for lamprey attachment.

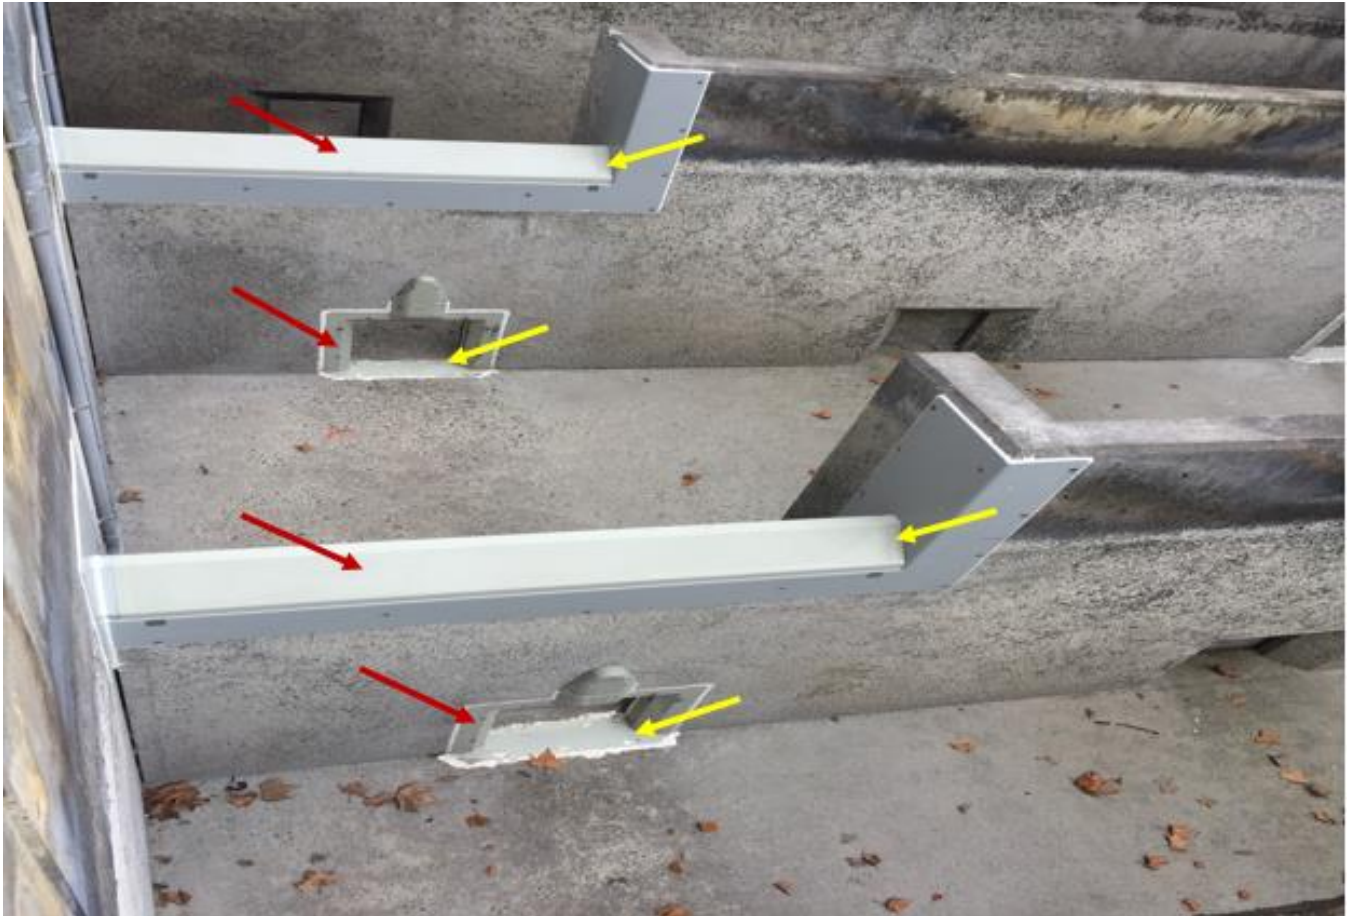
Picture 7. Typical JO1 and JO2 Weir and Overflow Antennas

- 8 antennas, 4 slot and 4 overflow style located in the middle section of the ladder just downstream of the counting window.

- 8 antennas, 4 slot and 4 overflow style located in the middle section of the ladder just downstream of the counting window,

- All antennas within the JDA North and South ladders are either embedded in or bolted onto the concrete of the ladder.
- In some instances, the ladder has been retro-fitted to receive a specific antenna geometry.

- Red arrows show placement of FDX antennas.
- Yellow arrows are examples of potential lamprey attachment locations.
- As picture indicates, antennas are smooth on all sides ideal for lamprey attachment.

- Slow but turbulent moving water.

- Smooth surfaces within antenna detection field, ideal for lamprey attachment.

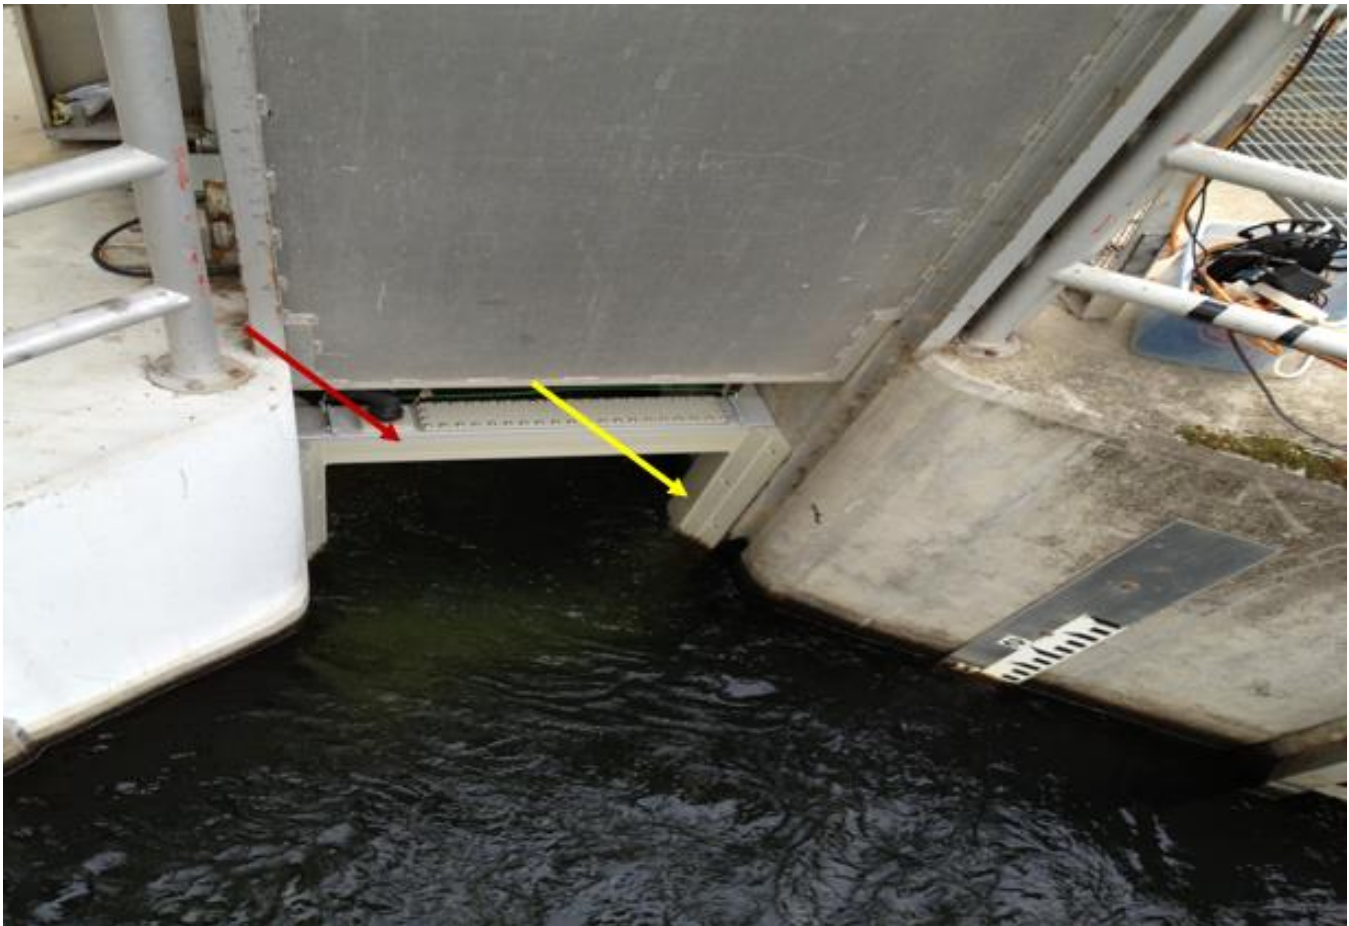
Picture 8. Typical TD1 and TD2 Counting Window antenna

- 2 antennas, pass-thru style, located within the confines of the counting window passage

- Metal frame mounted system, Co-Polymer antennas are custom built and designed around the existing metal frame and picketed leads

- RED arrows show placement of FDX antennas.
- Yellow arrows are examples of potential lamprey attachment locations.
- As picture indicates, antennas are smooth on all sides ideal for Lamprey attachment.

- Slow moving water
- Smooth surfaces within antenna detection field, ideal for lamprey attachment
- Areas behind the picketed leads where lamprey could and become entrained

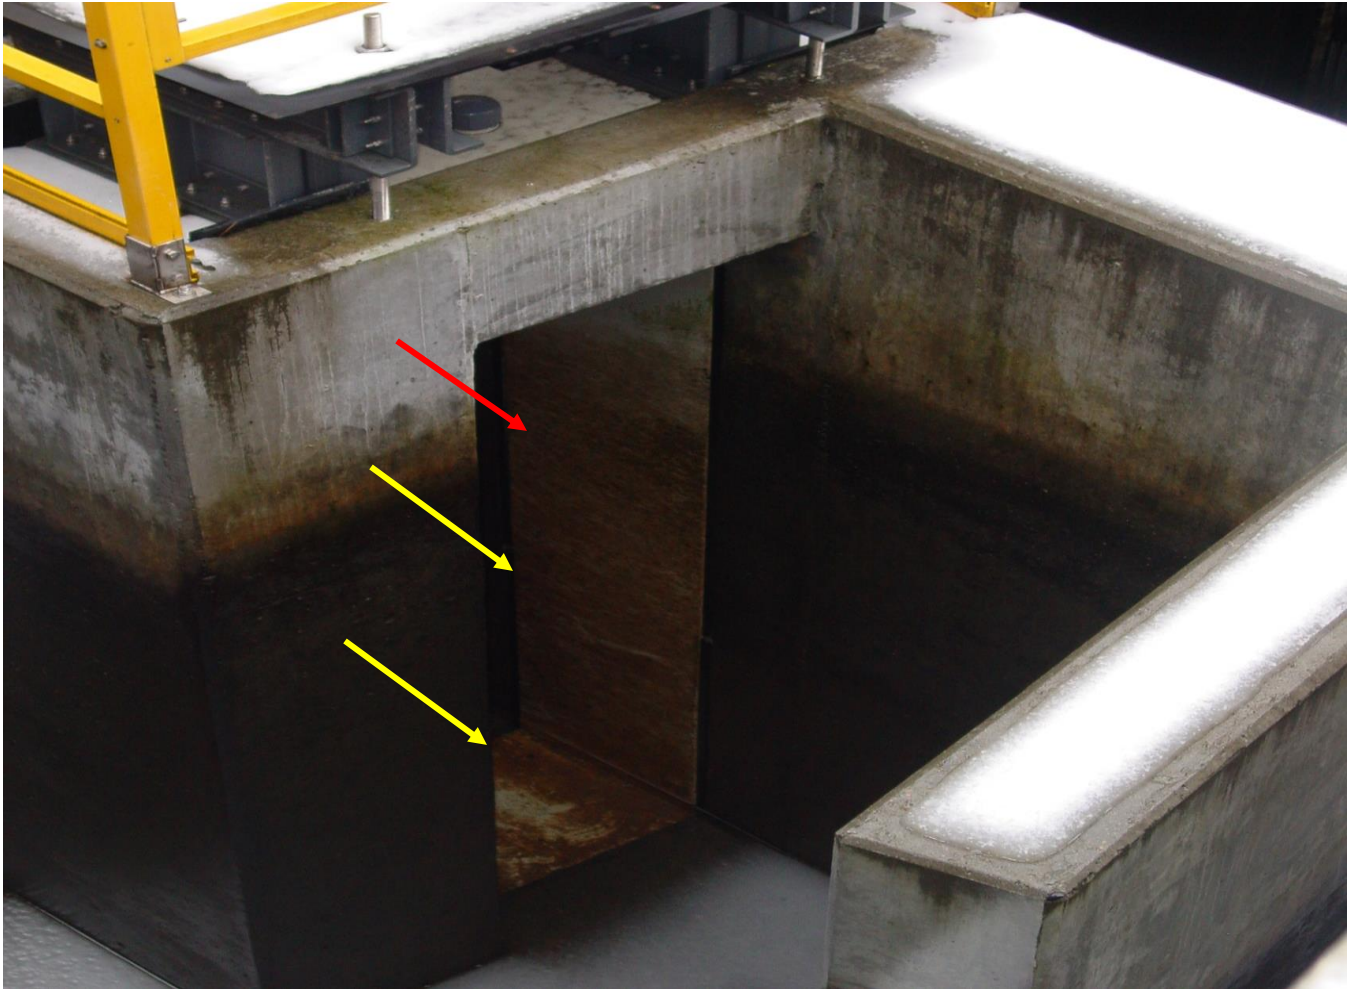
Picture 9. Typical BO1 and BO4 Slot antenna

- 4 Slot style antennas located in the upper ladder section near exit
- Typical for Bradford Is. and WA. Shore ladder.

- All 4 slot antennas within the BO1 ladder are either embedded in, or bolted onto the concrete of the ladder.

- Red arrows show placement of FDX antennas.
- Yellow arrows are examples of potential lamprey attachment locations.
- As picture indicates, antennas are smooth on all sides ideal for Lamprey attachment.

- Slow but turbulent moving water.
- Smooth surfaces within antenna detection field, ideal for lamprey attachment

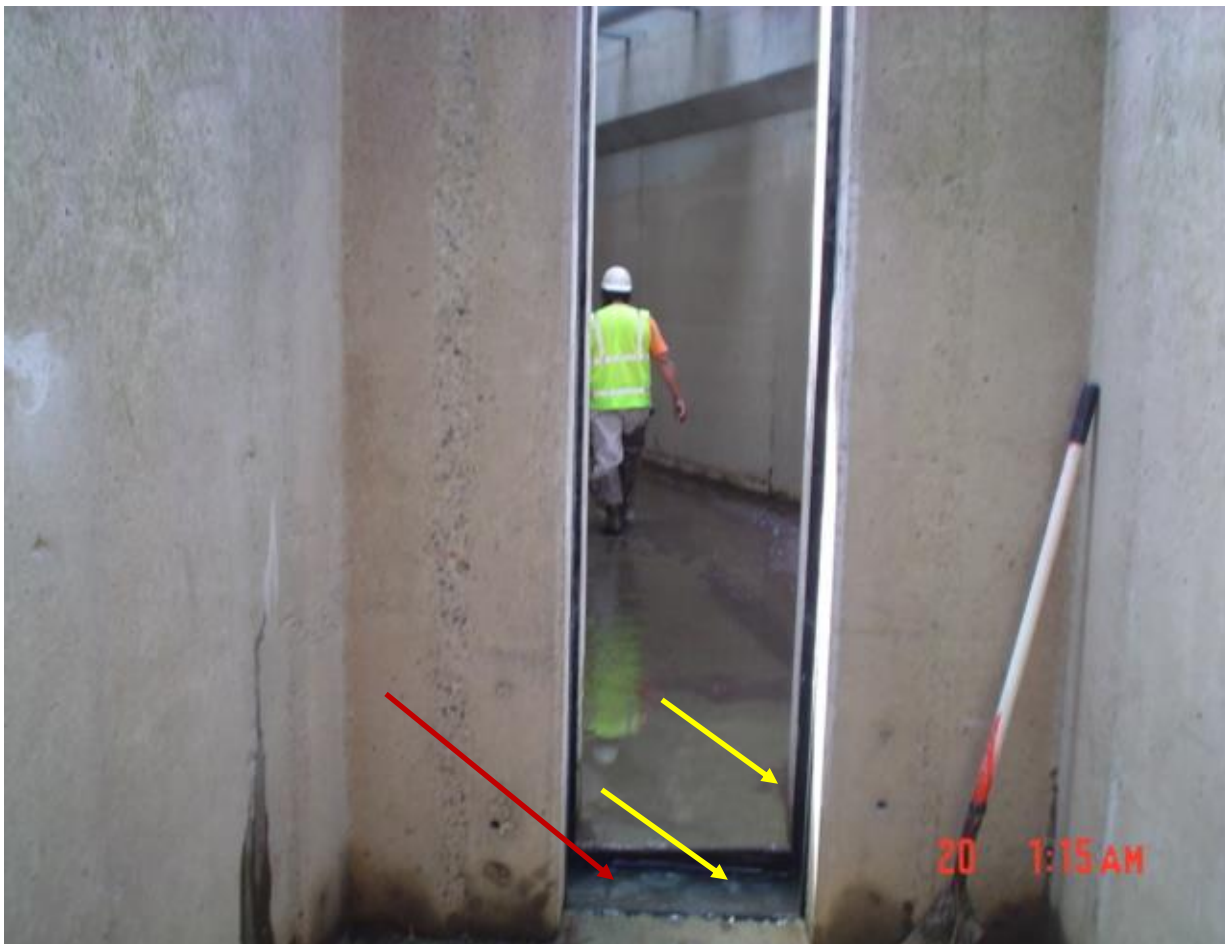
Picture 10. Typical LFF Orifice antenna

- 3 Slot style antennas located in the adult fish way bypass channel.

- All 3 slot antennas within the bypass channel are embedded in the concrete of the ladder.
- The adult fish way was built to accommodate these antennas.

- Red arrows show placement of FDX antennas.
- Yellow arrows are examples of potential lamprey attachment locations.
- As picture indicates, antennas are smooth on all sides ideal for Lamprey attachment.

- Slow moving water.
- Smooth surfaces within antenna detection field, ideal for lamprey attachment.

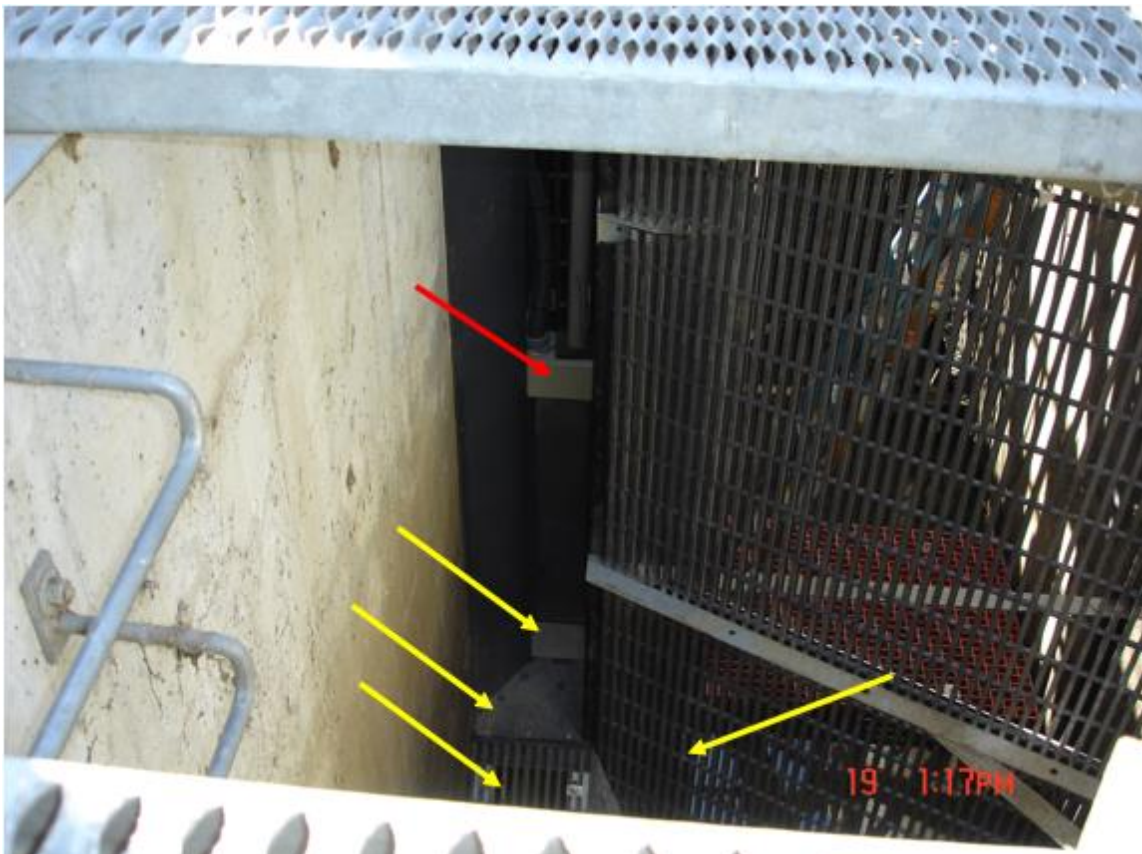
Picture 11. Typical PRO Counting Window antenna

- 3 counting window locations within Chandler Dam, Left, Center and Right counting windows.
- 2 pass-thru style antennas per counting window.

Fiberglass materials through out with a mix of existing steel reinforcement.

- Red arrows show placement of FDX antennas.
- Yellow arrows are examples of potential lamprey attachment and entrainment locations.
- As picture indicates, antennas are smooth on all sides ideal for lamprey attachment.

- Slow but turbulent moving water.
- Smooth surfaces within antenna detection field, ideal for lamprey attachment
- Areas behind the picketed leads where lamprey could attach and rest within the detection field.

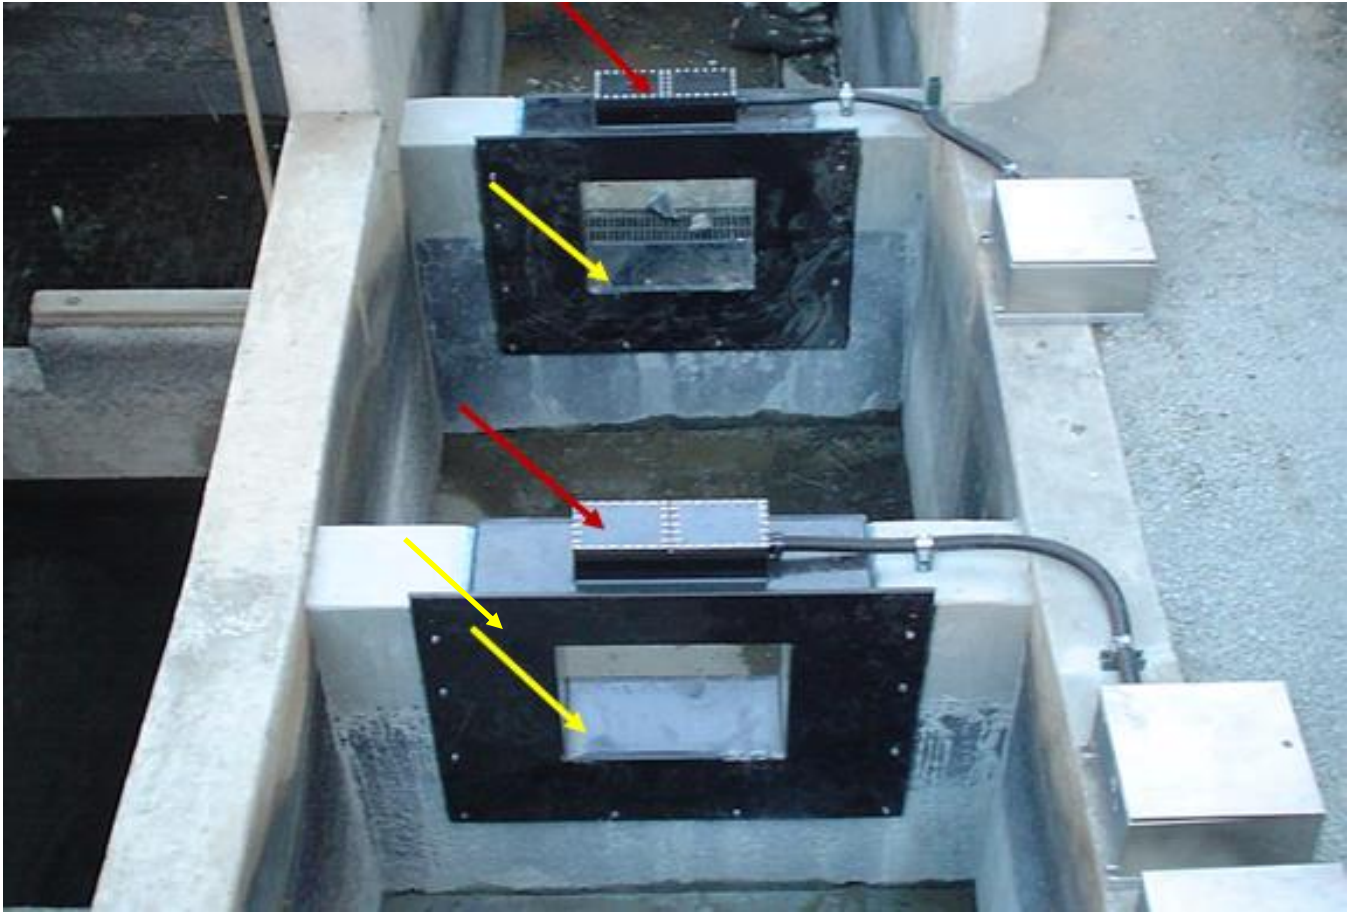
Picture 12. Typical ROZ Orifice antenna

- 3 pass-thru style antennas located in 3 weir walls.

- Concrete surroundings retro-fitted for the antenna geometry.

- Black arrows show placement of FDX antennas.
- As picture indicates, antennas are smooth on all sides ideal for lamprey attachment.

- Slow but turbulent moving water.
